**PHASE I
ENVIRONMENTAL SITE ASSESSMENT**

**Former Fast Food Restaurant
9615 Buckeye Road
Cleveland, Ohio 44139**

October 10, 2011

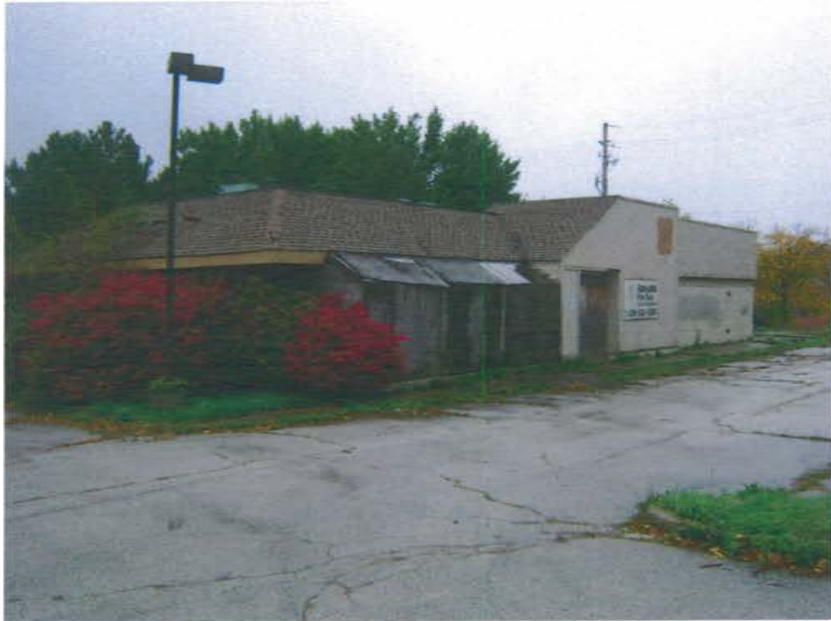
Photo 1
View facing north of the former Burger King restaurant located on the Property.

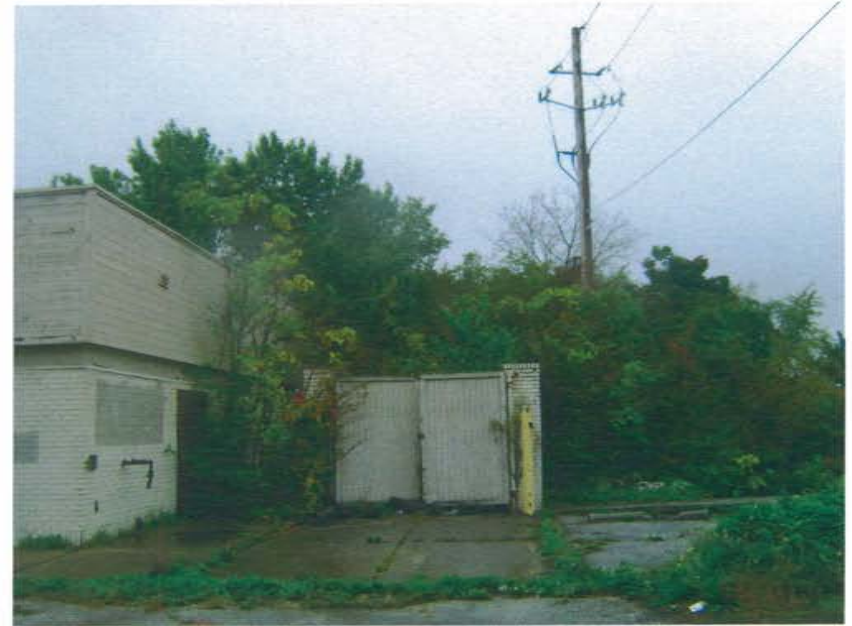
A wooden enclosure is located along the north exterior wall of the building on the Property previously housed the solid waste dumpster. A soil mound measuring approximately six (6) feet wide by three (3) feet and high covered in vegetation is present on the asphalt parking lot in the north-central portion of the Property. No surficial staining or discolorations were observed on the ground beneath the dumpster or around the soil mound. Based on the use of the dumpster and observations made during the site visit, it is unlikely that the dumpster or soil mound have adversely impacted the Property.

Photo 2
View facing west of the former solid waste dumpster enclosure located along the north exterior wall of the building on the Property.

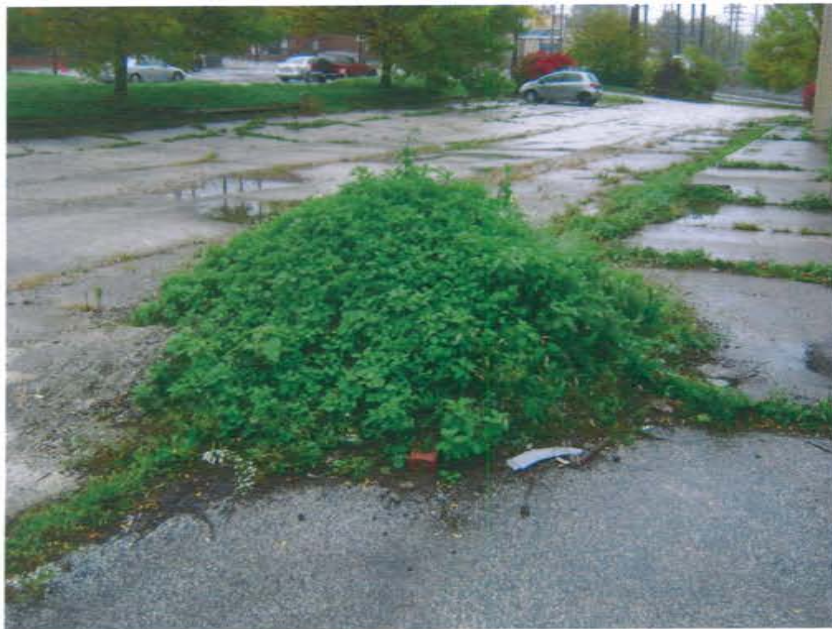
Photo 3
View facing south of the soil mound located on the northern portion of the Property.

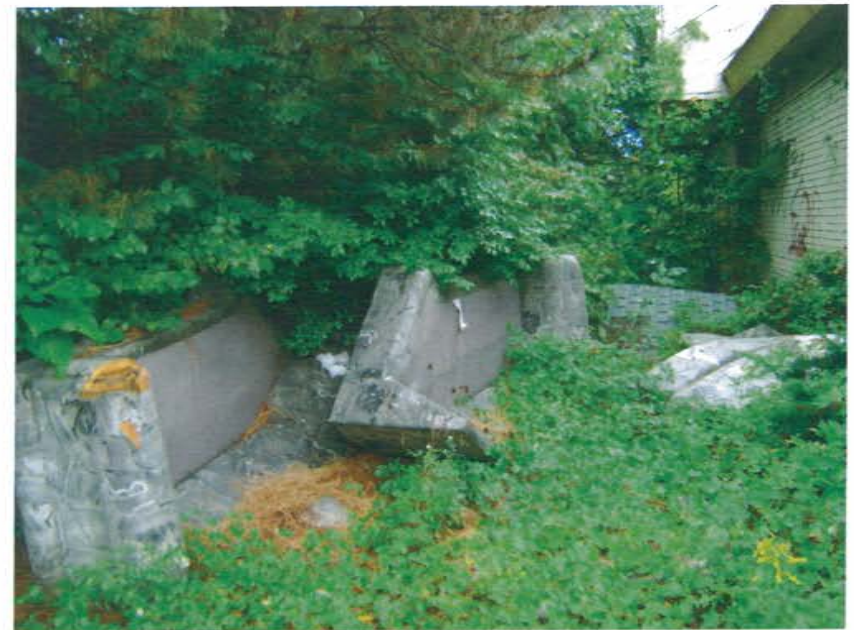
Exterior Features: A deteriorated drive-through lane surrounds the Former Fast Food Restaurant to the north and west. Piles of miscellaneous debris (couches, paper, bottles, etc.) and overgrown vegetation limited a visual inspection of the drive-through lane. An enclosure formerly utilized to house the solid waste dumpster extends from the north exterior wall of the building. Generally, asphalt paved parking lots are located north, east and south of the building. Trees and landscaped areas surround the perimeter of the Property. Ingress/egress to the Property is provided by access drives from Buckeye and Woodhill Roads to the south and east and Wamelink Avenue to the north. A soil mound measuring approximately six (6) feet wide by three (3) feet high and covered in vegetation is located on top of the asphalt parking lot in the north-central portion of the Property. Storm water catch basins are located in the paved parking lot.

Photo 4
View facing northeast of the miscellaneous trash blocking the drive-thru lane along the western Property boundary.

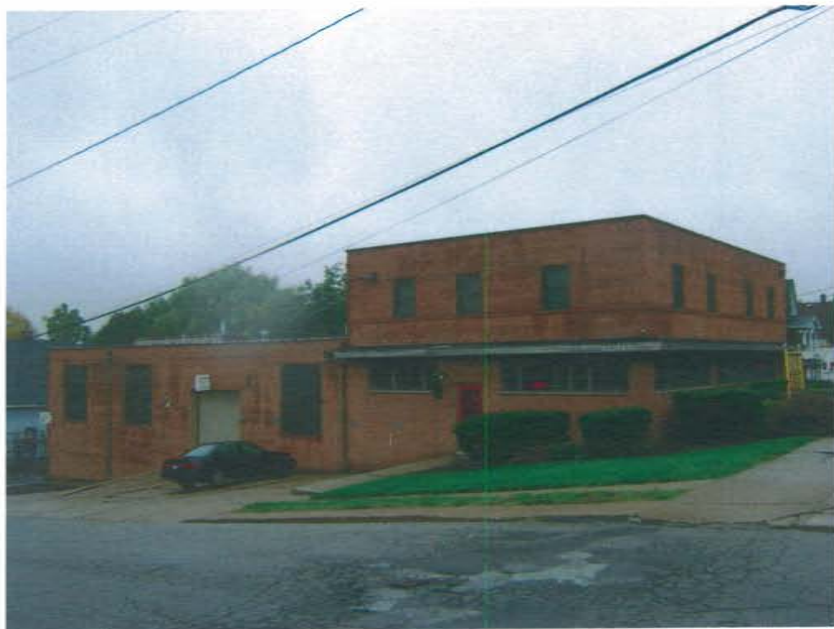
Photo 5
View facing north of north adjoining Guardian Company Cleaning Supplies facility (2754 Woodhill Road).

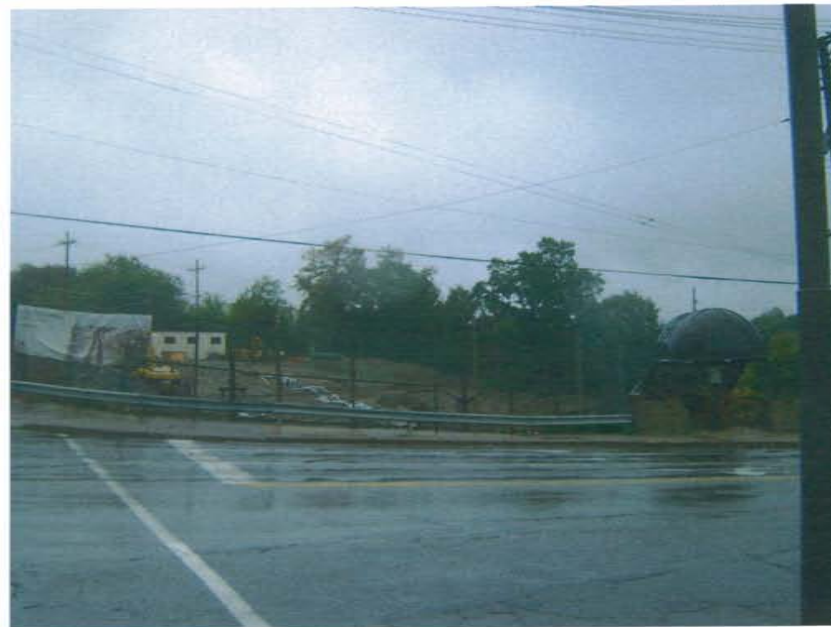
Partners observed a Transformer Substation located on the south adjoining Buckeye-Woodhill RTA Blue/Green Line Substation.

Photo 6
View facing southwest of the south adjoining Buckeye-Woodhill RTA Substation that is currently under construction.

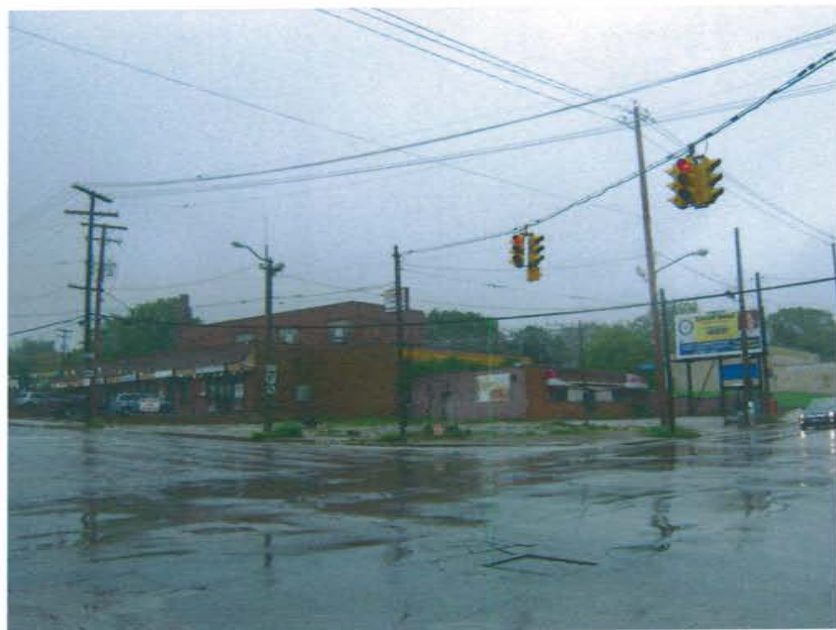
Partners observed a concrete pad in the same configuration as a former gasoline filling station located approximately 125 feet south of the Property (2795-2801 Woodhill Road). Refer to **Section 9.0** for additional information.

Photo 7
View facing southeast of the south adjoining former gasoline filling station (2795-2797 Woodhill Road) and multi-tenant commercial building (9718 Buckeye Road).

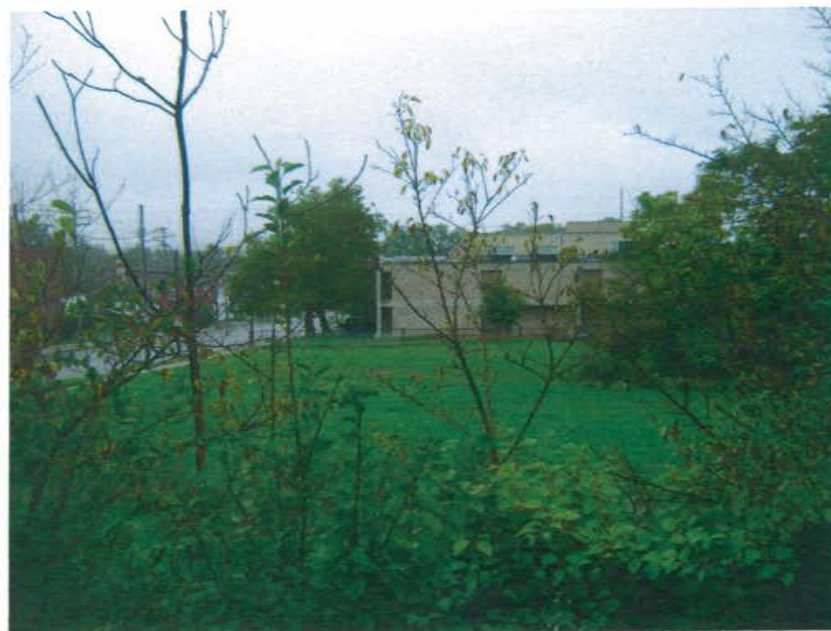
Photo 8
View facing northwest of the west adjoining vacant grass lots and the Buckeye-Woodland Elementary School (9511 Buckeye Road).

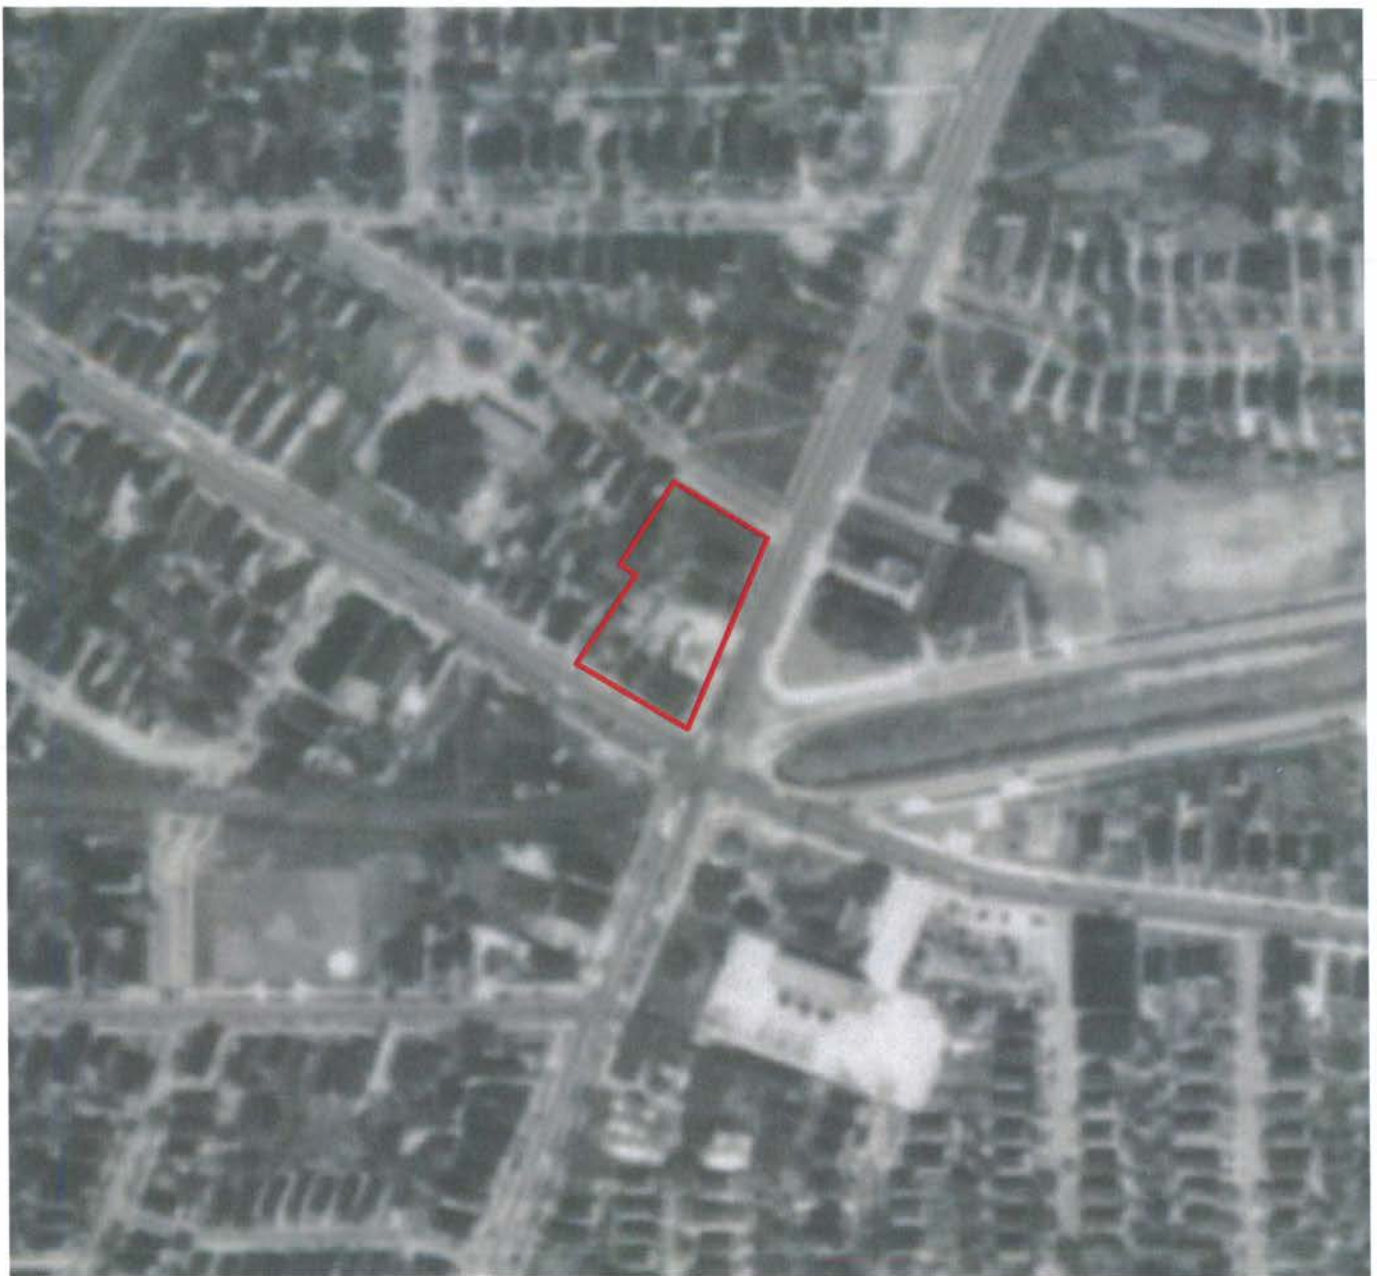
1951 - Aerial Photograph

1951: The Property and surrounding area is developed; however, the poor resolution of the aerial photograph makes it difficult to discern structures. The Property appears to be developed with residential structures on the northern and southwestern portions, a storefront on the southeast corner and a rectangular structure surrounded by a paved parking area on the south-central portion. This structure is in the same configuration as an auto repair facility and gasoline filling station shown in Sanborn Fire Insurance (Sanborn) maps.
